U.S. CHEMICAL SAFETY AND HAZARD INVESTIGATION BOARD

INVESTIGATION REPORT

XCEL ENERGY HYDROELECTRIC PLANT PENSTOCK FIRE (Five Dead, Three Injured)

REPORT No. 2008-01-I-CO

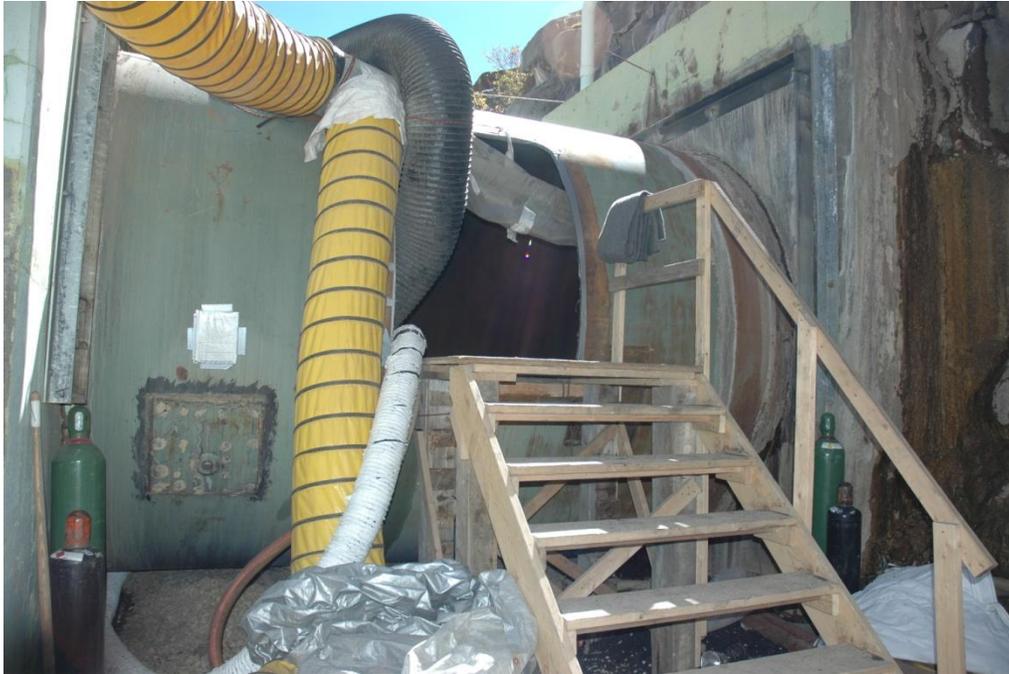
Figure 4. Access door cut into penstock for recoating work

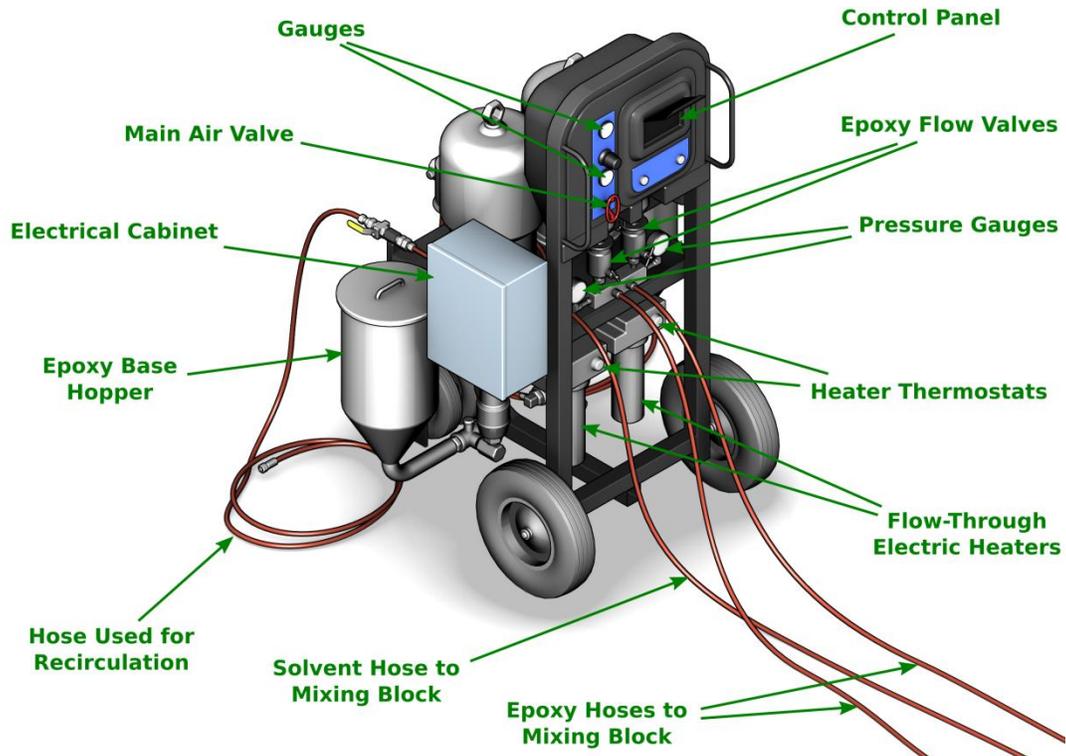
Figure 5. The epoxy sprayer system used within the penstock

Solvent, such as MEK, is needed if problems arise when applying the epoxy mixture. If the combined epoxy product was to set, it would harden within the hoses and spray wands, destroying the equipment. Solvent would be used to flush out the mixing block and hoses to the spray wands to ensure that the epoxy mixture was fully removed from the equipment and would not permanently render it unusable. Solvent would be introduced into these portions of the spray system using a third smaller pump on the back of the machine that would take in solvent from an open bucket placed on the ground at the back of the sprayer (Figure 6). A hose ran directly from this pump to the mixing block.

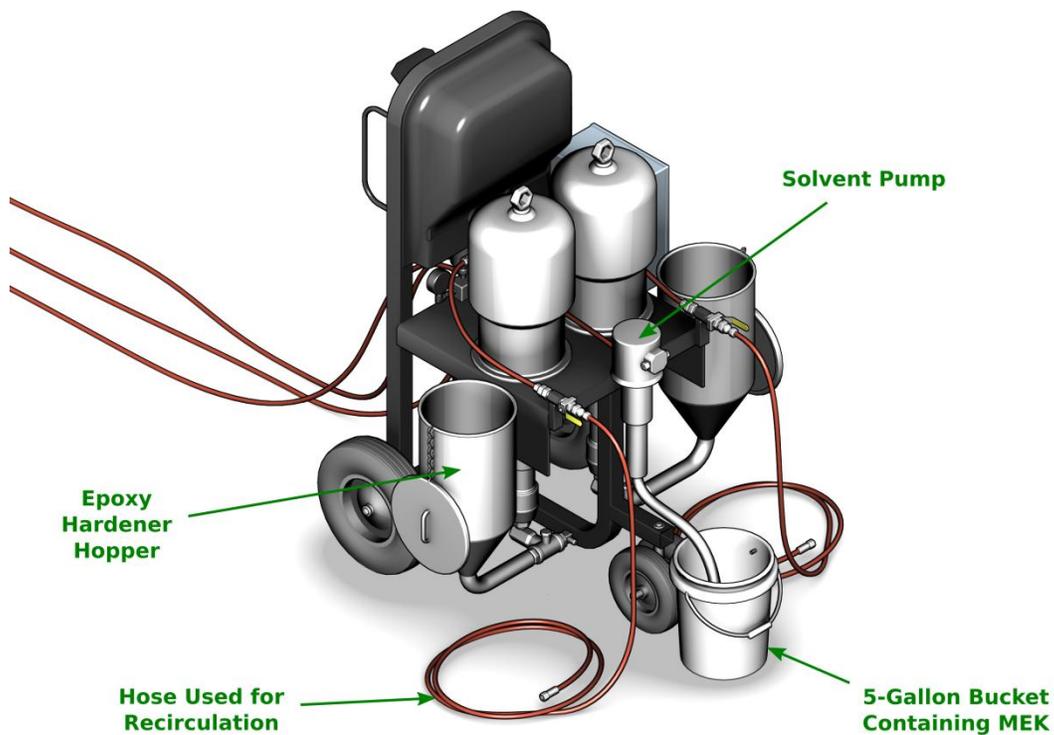
Figure 6. The solvent pump on the back side of the epoxy sprayer

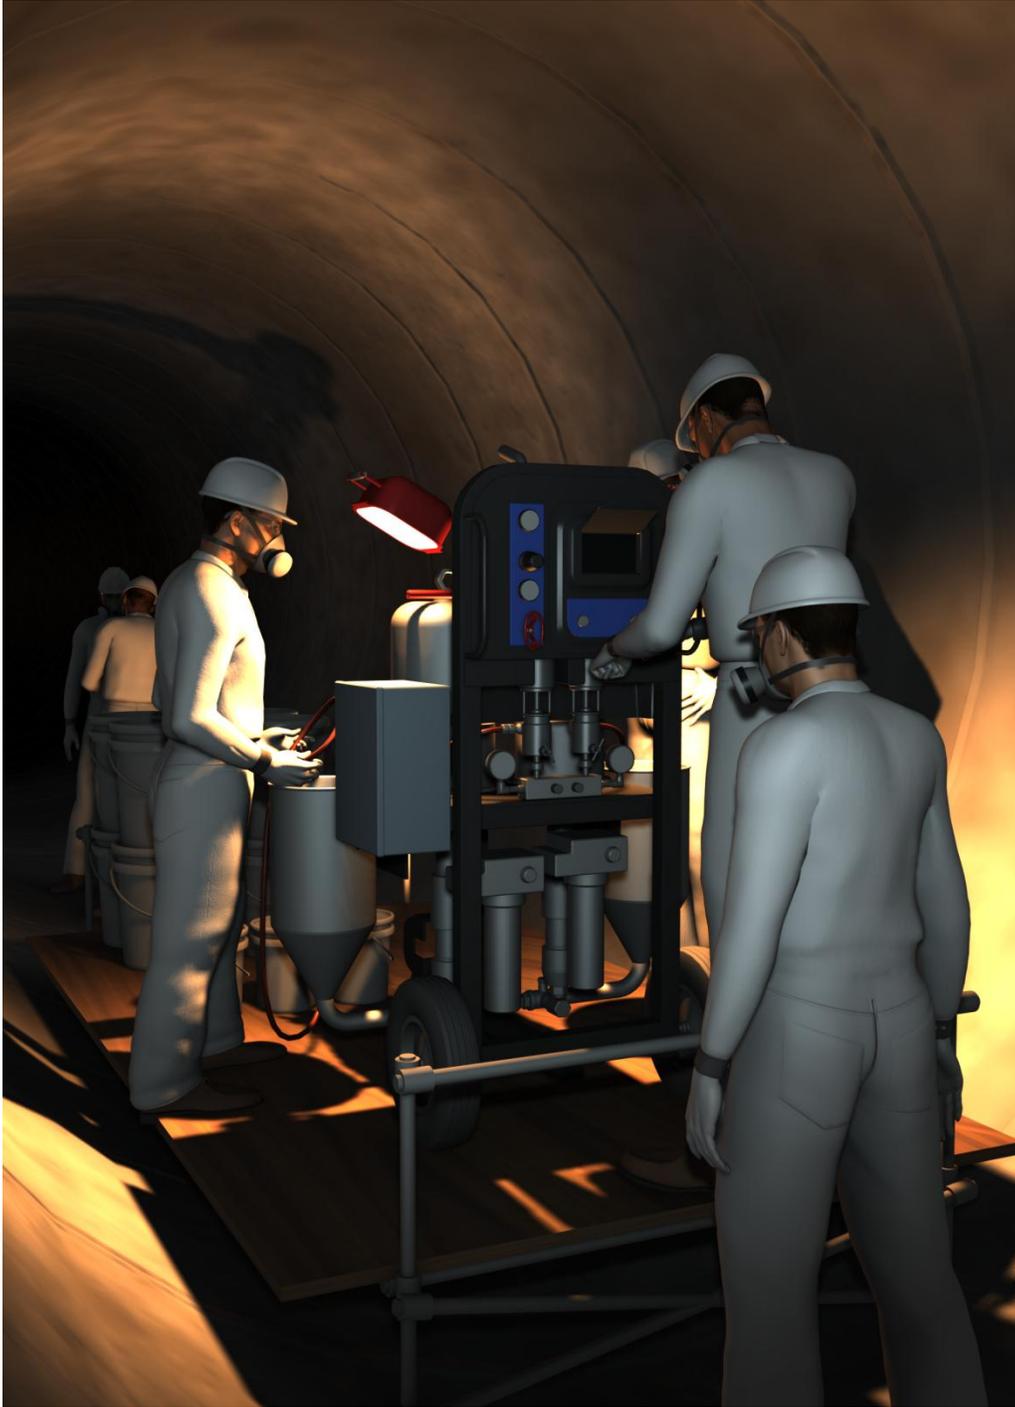
In the hour leading up to the incident, five of the 13 contractors were working around the sprayer system (Figure 8). Three of these individuals – two of whom were foremen – worked the controls of the sprayer, while two others were stationed on the sides, each responsible for manning a hopper. Four additional contractors were runners, bringing epoxy, solvent, and other equipment to and from the work area to assist the five at the sprayer, and one person was stationed as the “hole watch” attendant at the access door 1,450 feet (442 meters) away.²²

Figure 8. Depiction of contractors working with the sprayer immediately prior to the flash fire

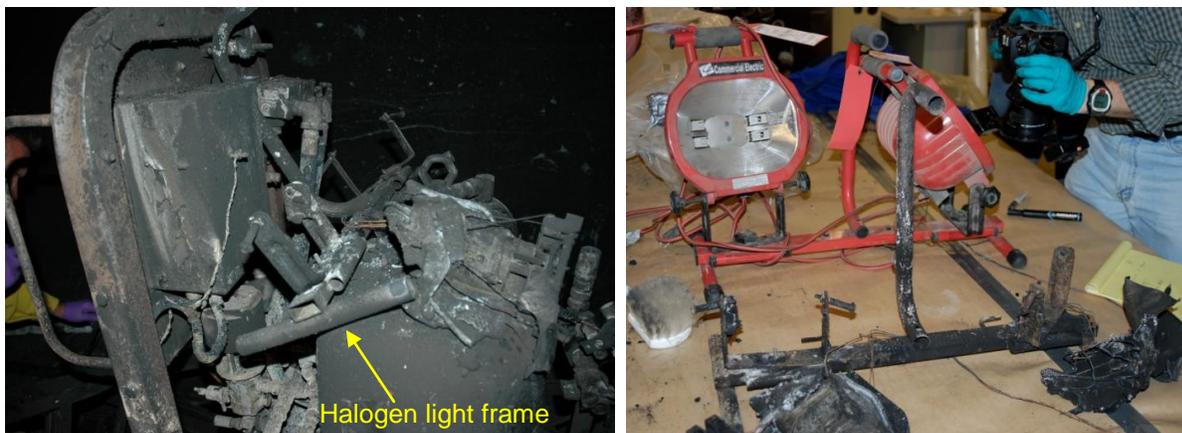
Unsafe lighting was also used within the penstock when flammables were present. RPI's "Spraying Equipment and Operations" policy within its IIPP states: "Explosion proof [sic] portable lamps must be used to illuminate the spray areas." However, the penstock spray area, including where the sprayer system was setup, was illuminated with a variety of lighting, not all of which was explosion-proof. Specifically, several halogen lamps were placed around the sprayer, with one resting on top of the sprayer pumps at the time of the incident (Figure 10).

Figure 10. Remains of the halogen light sitting atop the sprayer inside the penstock (left); the same remains being compared to an exemplar halogen light (right).

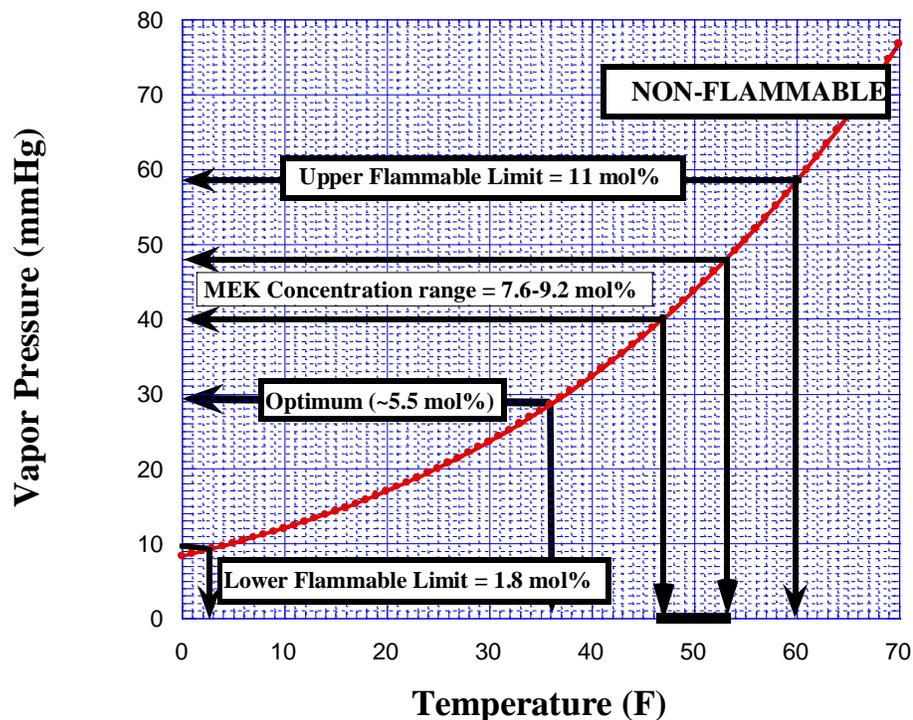
At 523 mmHg, the vapor-liquid equilibrium curve (Figure E-1) shows that the lower and upper flammable limits of MEK in air (1.8-11 volume percent) are attained at respective equilibrium temperatures of 3 to 60 °F (-16 to 15 °C). Between these temperatures, MEK vapor in equilibrium with liquid, such as deep inside the liquid hoppers on the sprayer, is ignitable. MEK vapor becomes most easily ignitable at an “optimum” concentration of about 5.5 volume percent, attained at an equilibrium temperature of about 36 °F (2.4 °C).

Figure E- 1. Equilibrium vapor pressure of MEK near liquid surface in base hopper

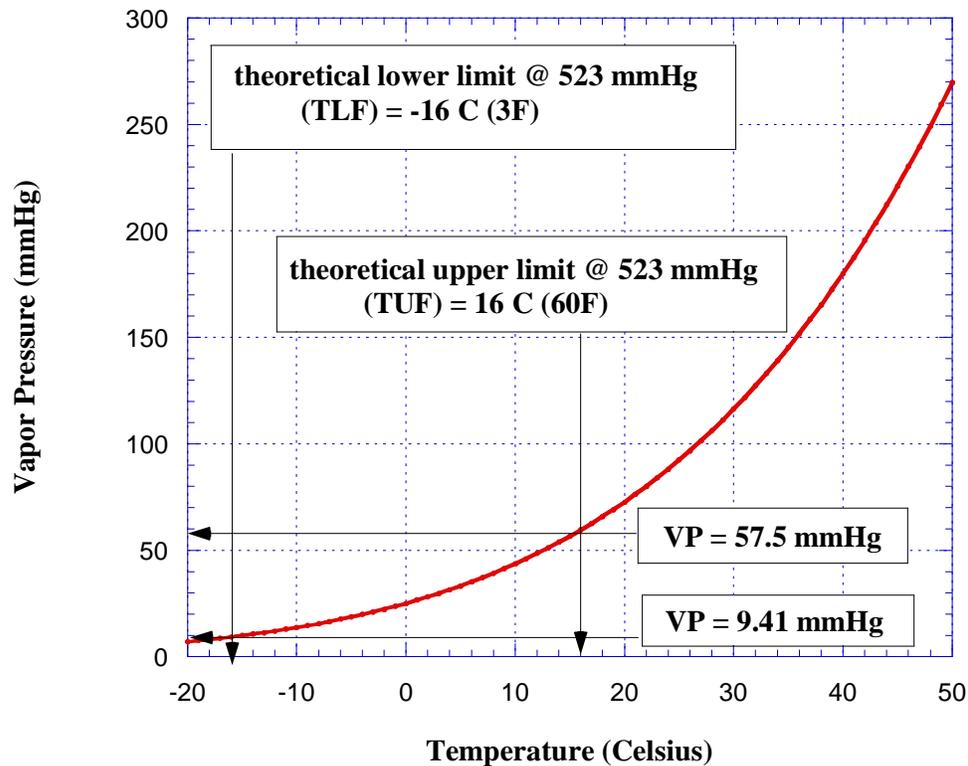
Similarly, the “upper temperature limit of flammability” (UFL) can be calculated. The UFL is generally not sensitive to pressure in the range being considered, so the corresponding MEK vapor pressure is 57.5 mmHg to achieve 11 mole percent MEK in the vapor and the theoretical upper flammability limit (TUF) is found to be 15 °C (60 °F). This result shows that MEK in the penstock could be within the flammable range (ignitable) at all times inside a pail or hopper.

Figure E- 2. Theoretical MEK flammability limits at penstock conditions

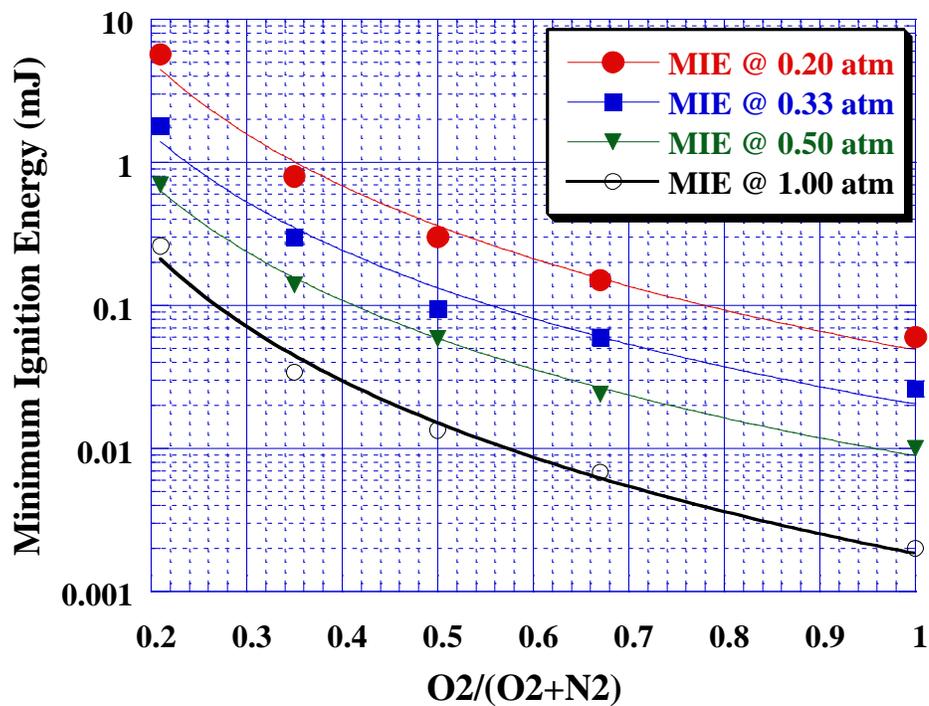
However, the LMIE generally increases as pressure decreases. In the penstock, the ambient pressure was about 523 mmHg (0.69 atmospheres). By analogy with data for propane (Figure F-1), the LMIE of MEK at 0.69 atmospheres (523 mmHg) should be approximately 0.5 mJ. (Britton, 1999):

Figure F-1. Effect of pressure on MIE of propane in various oxygen-nitrogen mixtures

Hence, the lowest MIE for MEK is approximately 0.5 mJ (5.50 mole percent MEK in dry air at 298 K, 0.69 atm).
