CASE STUDY

Fire at Formosa Plastics Corporation: Evaluating Process Hazards

2006-01-I-TX

Point Comfort, Texas
October 6, 2005

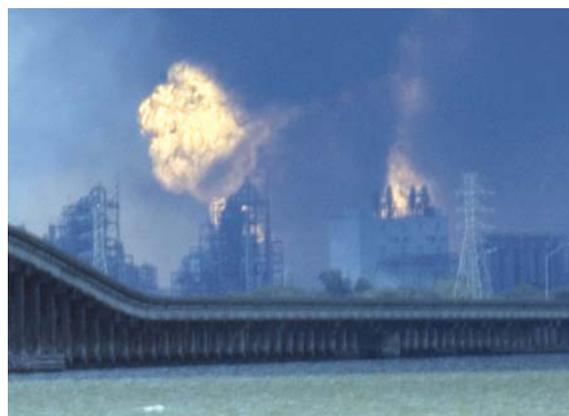
Figure 1. Point Comfort fire.

At about 3:07 PM, the vapor ignited, creating an explosion.² The explosion knocked down several and burned two (one seriously) operators exiting the unit. Flames from the fire reached more than 500 feet in the air (Figure 1).

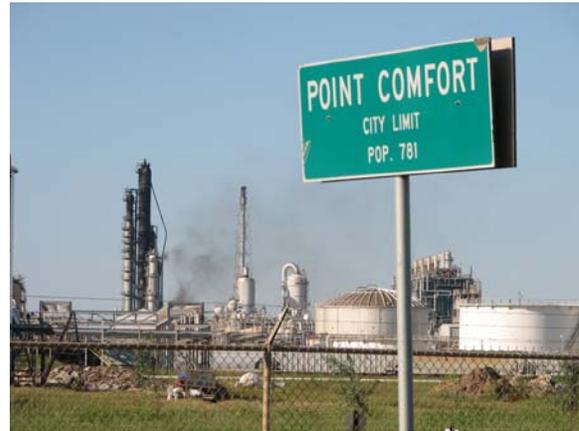
Figure 2. View of the Damaged Plant from Highway 35.

Within minutes of the initial explosion, local officials ordered a shelter-in-place for the Point Comfort community and closed Highway 35 that runs adjacent to the Formosa complex and through Point Comfort (Figure 2). Students and staff at the Point Comfort Elementary School evacuated to Port Lavaca, about five miles away. Local officials rescinded these measures by 9:00 PM that night.

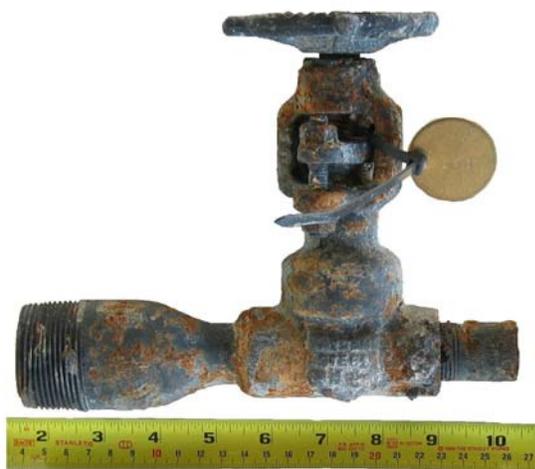
Figure 4. Valve and pipe.

- A worker driving a fork truck towing a trailer under a pipe rack backed into an opening between two columns to turn around.
- When the worker drove forward, the trailer caught on a valve protruding from a strainer in a propylene piping system.
- The trailer pulled the valve and associated pipe (Figure 4) out of the strainer, leaving a 1.9-inch diameter opening.⁶

⁶ The valve was attached to a pipe that was threaded into the strainer cover.

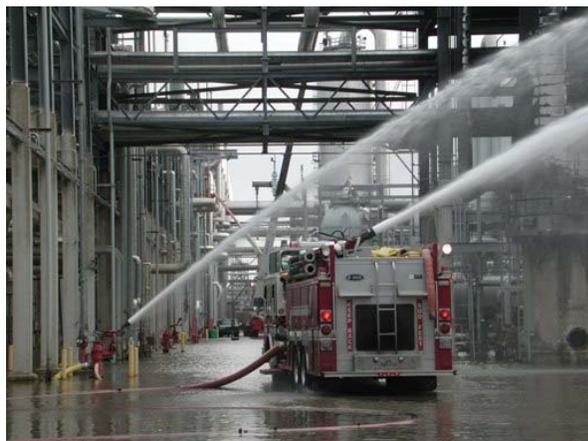
Figure 5. Formosa ERT equipment.

- The Formosa ERT arrived and took command of the incident response (Figure 5).

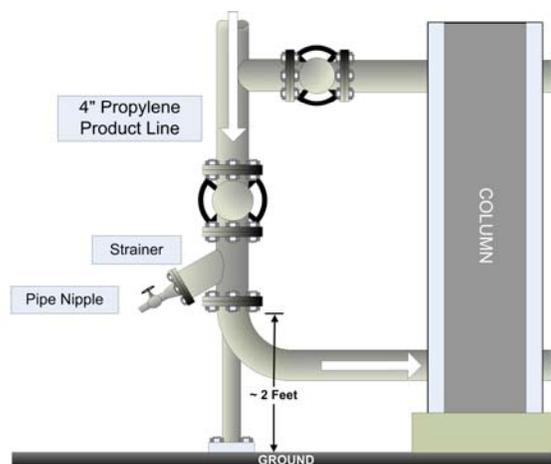
Figure 6. Pipe and valve arrangement.

The propylene piping involved in this incident protruded into an open space, yet had no impact protection (Figure 6).

The plant design drawings designate specific access ways for vehicles; these are not physically marked in the unit. The area where the impact occurred was not a designated access way but was large enough for a vehicle to easily pass.

The ASME B31.3 “Process Piping Code” states, “Impact forces caused by external or internal conditions shall be taken into account in the design of piping.”

Revise policies and procedures for process hazard analysis and pre-startup safety review to more fully evaluate vehicle impact hazards, passive fire protection, and catastrophic releases.

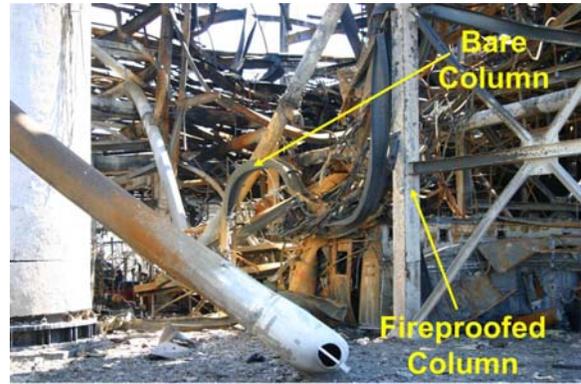
Figure 7. Fireproofed and bare steel support columns.

During the fire, part of a structure supporting the relief valves and emergency piping to the flare header collapsed. The collapse caused several pipes to crimp, likely preventing flow through the pipes and leading to the rupture of major equipment and piping that added fuel to the fire.

Passive fire protection (fireproofing⁹) was installed on only three of four support column rows and the columns that supported the pressure relief valves and emergency vent piping had no fireproofing (Figure 7). The bare steel columns bent over, while the fireproofed columns remained straight.

Had the steel been fireproofed as API recommends, the consequences of this incident would likely have been less severe.

Kellogg sold the plant design used at Formosa multiple times between the mid-1980s and 2000. However, the design was not updated to incorporate improved recommended practices with respect to fireproofing structural steel that supports critical safety systems.

Evaluate the applicability and use of current consensus safety standards when designing and constructing a chemical or petrochemical process plant. This should include reviewing and updating earlier designs used for new facilities.

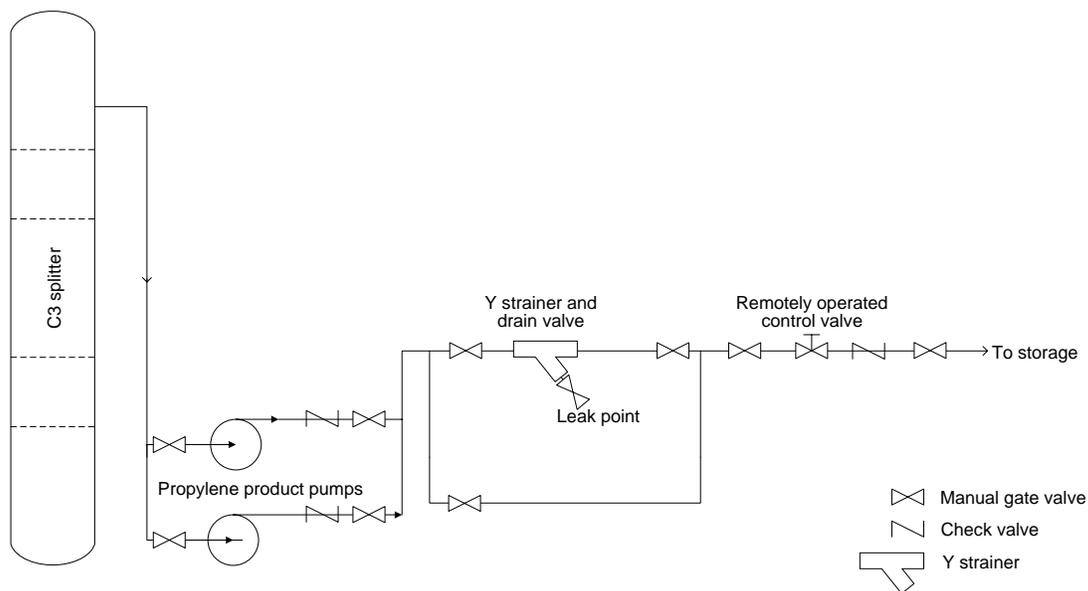
Figure 8. Propylene product flow.

Figure 8 shows the general arrangement of the piping and valves around the leak point. The leak occurred between manual block valves and a remotely operated control valve. While a check valve and remotely operated isolation valve downstream of the leak prevented the backflow of propylene from product storage, operators were unable to reach the manual valves capable of stopping the flow from the distillation column. The operators were also unable to reach the local control station to turn off the pumps supplying propylene, although they eventually turned off the pumps at the motor control center located in the control room building, slowing the rate of propylene feeding the fire.

Had a remotely actuated valve been installed upstream of the pumps, this incident would likely have ended quickly, possibly even before ignition occurred. Additionally, had

remote control of the pumps been possible from the control room, the propylene flow could have been quickly reduced, potentially reducing the severity of the incident.

Had Formosa been able to isolate the major hazard inventories in the unit as recommended in industry guidance, the consequences of this incident would likely have been lessened.

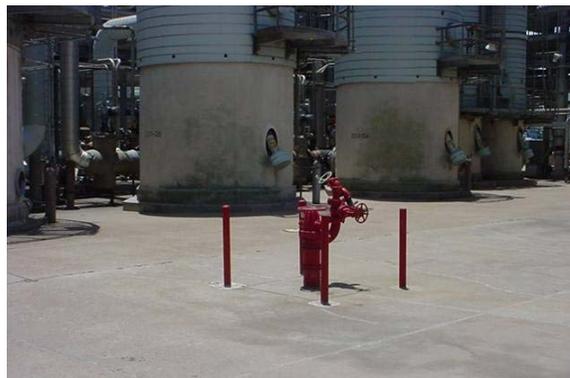
Figure 9. Protection of fire fighting equipment.

The contrast between the physical protection for firefighting equipment and the administrative provisions for process piping and other equipment is striking. Figure 9 shows the protection afforded firefighting equipment, while Figure 10 shows the lack of protection where the impact and release occurred.

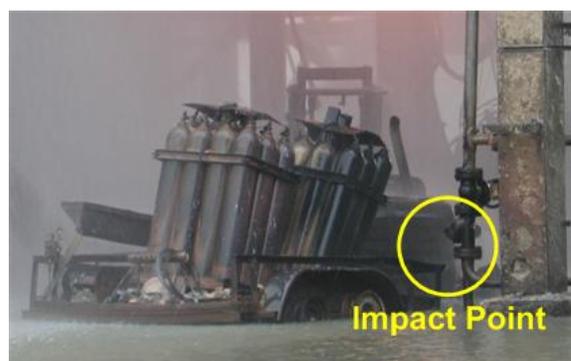
Figure 10. Vehicle impact point.

During the facility siting analysis, the hazard analysis team discussed what might occur if a vehicle (e.g., fork truck, crane, man lift) impacted process piping. While the consequences of a truck impact were judged as “severe,” the frequency of occurrence was judged very low (i.e., not occurring within 20 years), resulting in a low overall risk rank.¹¹ Because of the low risk ranking, the team considered existing administrative safeguards adequate and did not recommend additional traffic protection.

When performing a hazard analysis, facility siting analysis, or pre-startup safety review, vehicle impact and remote isolation of catastrophic releases should be investigated.
