# CASE STUDY

## Polyethylene Wax Processing Facility Explosion and Fire

No. 2005-02-I-TX  
June 2006

### Marcus Oil and Chemical

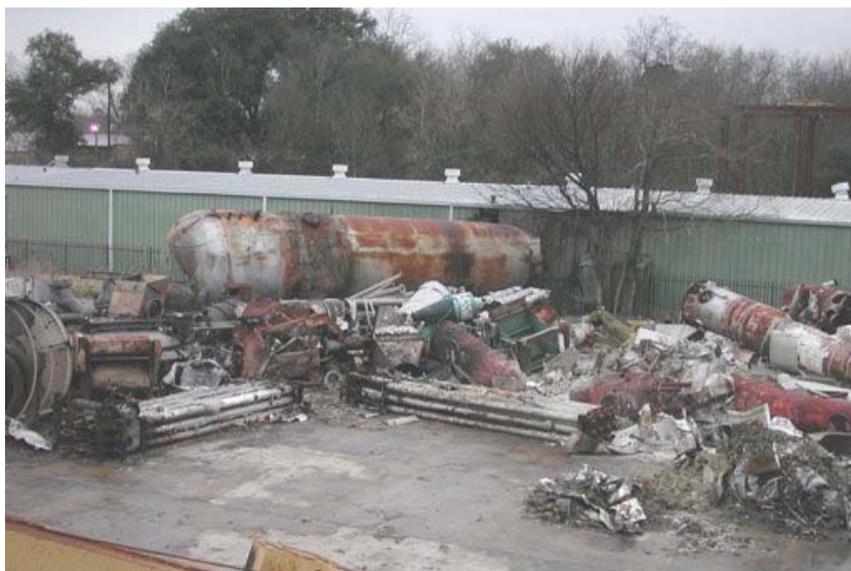
Tank 7, a 12-foot diameter, 50-foot long, 50,000-pound pressure vessel was propelled 150 feet where it impacted a warehouse

belonging to another business (see cover photograph). Figure 1 shows the displacement of Tank 7 from its installed location.

- The 50,000 lb vessel was propelled into surplus equipment stored nearby, and came to rest against a warehouse on an adjacent property more than 150 feet away (see cover photograph).
- Burning polyethylene wax was blown against the warehouse and other equipment and ignited combustible materials. The resulting fire burned for nearly seven hours.

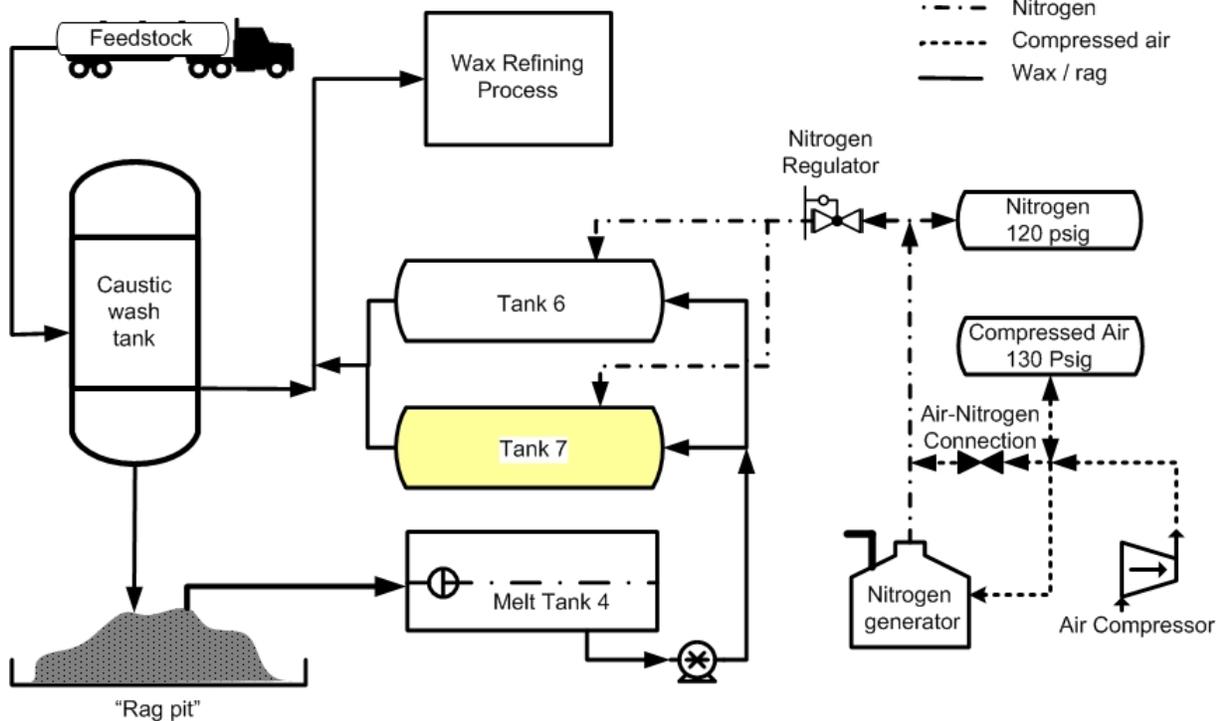
Figure 2. Simplified Process Flow Diagram.

Figure 2 is a simplified process flow diagram. The normal process started with pumping feedstock from tanker trucks into a wash tank where impurities settled to the bottom.

Marcus Oil management reported that nitrogen was used throughout the process equipment to protect the molten wax from contact with oxygen in the air. Oxidation caused the bright-white wax to discolor, an unacceptable condition.

Operators periodically removed the residual wax with concentrated impurities (called "rag") from the wash tank. The removed rag solidified and was stored in the warehouse for later processing.

The wax then was processed to extract hexane and other hydrocarbons, solidified

Marcus Oil installed a connection between the nitrogen and compressed air systems (see Figure 2) to provide rapid repressurization of the nitrogen system when the nitrogen pressure was too low to move the molten wax from the tanks to the process unit. The company assumed that compressed air was an acceptable substitute for nitrogen during rag wax processing. During rag processing, product discoloration from air exposure was not a concern. However, management did not evaluate the hazards that resulted from this process change.

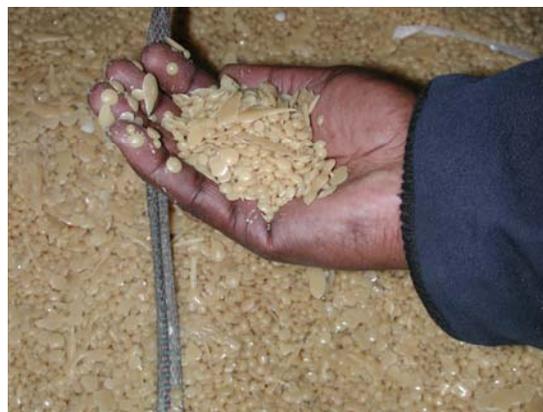
**Figure 3. Wax Pellets from Processed Rag**

Operators used the nitrogen system to pressurize Tanks 6 and 7 to force the liquid rag through an elevated section of pipe connected to the process unit feed pump. The rag was pumped through the process unit to remove residual hydrocarbons. The refined rag was solidified into small pellets (Figure 3), packaged, and shipped.

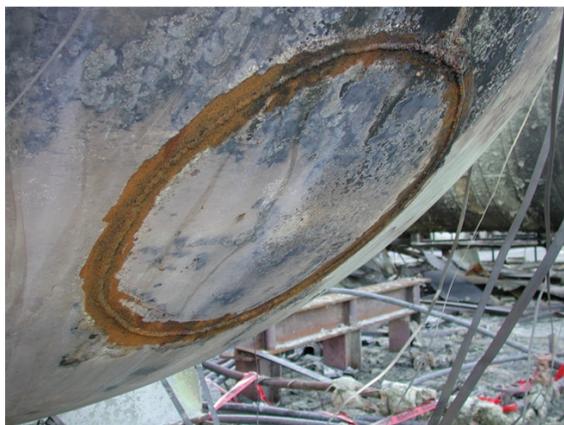
**Figure 4. 24-inch patch plate on Tank 8.**

The CSB found that Marcus Oil had altered<sup>7</sup> Tanks 5 - 8: each had a 24-inch diameter temporary opening cut into one end to install a steam pipe that heated the wax above the melting temperature. Following the pipe installation, the opening was welded closed.

The as-welded patch plate on Tank 8 is shown in Figure 4. The patch plates on

Tanks 5 and 6 were essentially the same. Although the Tank 7 patch plate was not recovered, CSB investigators concluded that it matched the other three tank patch plates.

Implement the requirements of the National Board Inspection Code (NB-23) to repair all pressure vessels that have been altered at the facility. Require the application of NB-23 to all future pressure vessel repairs and alterations.

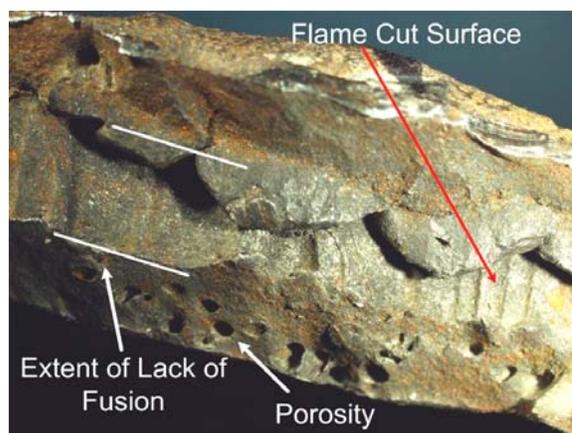
**Figure 5. Recovered patch plate weld from failed Tank 7.**

The weld used to reclose the temporary opening on Tank 7 failed during the incident because the repair weld (Figure 5) did not meet generally accepted industry quality standards for pressure vessel fabrication. The original, flame-cut surface was not ground off the plate edges before rewelding the joint. The weld did not penetrate the full thickness of the vessel head. Furthermore, the welds contained excessive porosity (holes from gas bubbles in the weld). These defects significantly degraded the strength of the weld.

Marcus Oil did not use a qualified welder or proper welding procedure to reweld the plate on the vessel heads and install the steam pipe nozzles in the shells. Marcus Oil personnel also acknowledged that they did not hydrostatically pressure test<sup>8</sup> the vessels after

Improper alteration of Tank 7 led to its failure: the closure weld used to reinstall the patch plate was fused less than 25% through the thickness of the plate and contained numerous flaws.

The effect of the inadequate closure weld was two-fold. First, it decreased the strength of this part of the tank by more than 75 percent. Second, the lack of weld fusion and poor quality likely caused pressure-cycle induced

Had Marcus Oil complied with NB-23, the closure weld on the Tank 7 patch plate would have been required to be as strong as the original vessel welds, and hydrostatically tested to verify it was welded correctly before returning the vessel to pressure service.

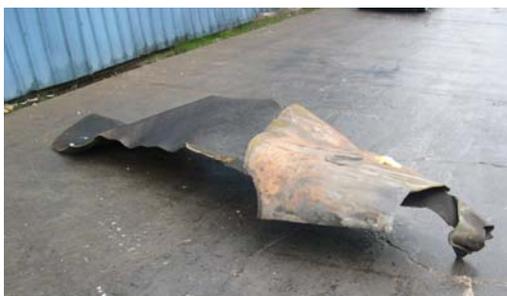
**Figure 6. 750-pound Tank 7 fragment landed near employees.**

- Operators pressurized Tanks 6 and 7 with nitrogen gas containing 18 percent oxygen instead of the intended concentration of not more than 8 percent oxygen.
- The internal pressure of Tank 7 (67 psig) likely exceeded the strength of the defective weld on the patch plate. The weld completely failed, severing the plate from the tank.
- The tank rapidly depressurized through the 24-inch hole. Hydrocarbon vapor, compressed air, and hot liquid wax were ejected through the hole.
- Sparks were generated when the patch plate struck the concrete pad, and likely ignited the wax and hydrocarbon vapors.
- The oxygen concentration in Tank 7 permitted the flame to flash back into the vessel. An internal deflagration blew the vessel head into multiple fragments (Figures 1, 6, and 7).

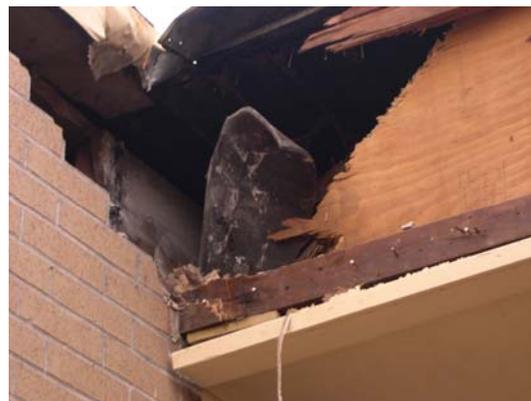
**Figure 7. 20-pound Tank 7 fragment embedded in building wall 300 feet from the Marcus Oil property line.**

Other significant explosion debris thrown into the community included a 20-pound steel plate found lodged in a building 500 feet away; a 120-pound steel plate found in a pasture 900 feet away; and a 2-pound steel plate found in the yard of a local residence one-quarter mile away.
