U.S. CHEMICAL SAFETY AND HAZARD INVESTIGATION BOARD

INVESTIGATION REPORT

XCEL ENERGY HYDROELECTRIC PLANT PENSTOCK FIRE (Five Dead, Three Injured)

REPORT No. 2008-01-I-CO

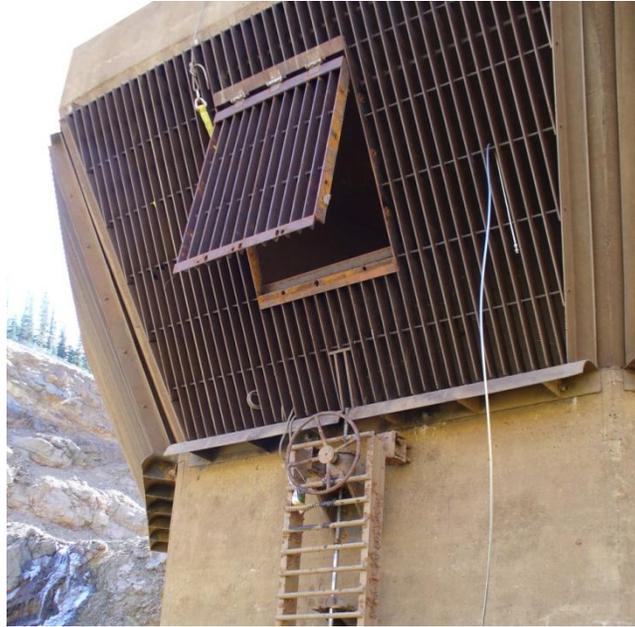
Figure 3. Upper reservoir mushroom access hatch

At the highest elevation point of the penstock in the upper reservoir is the intake structure known as the “mushroom.” The mushroom is a 40-foot (12 meter) tall, cylindrical concrete and steel tower with screened openings near the top that open to the penstock. The mushroom has an access hatch approximately 20 feet (6.1 meters) above grade at a reverse incline position that requires climbing skill and significant physical strength to enter (Figure 3).

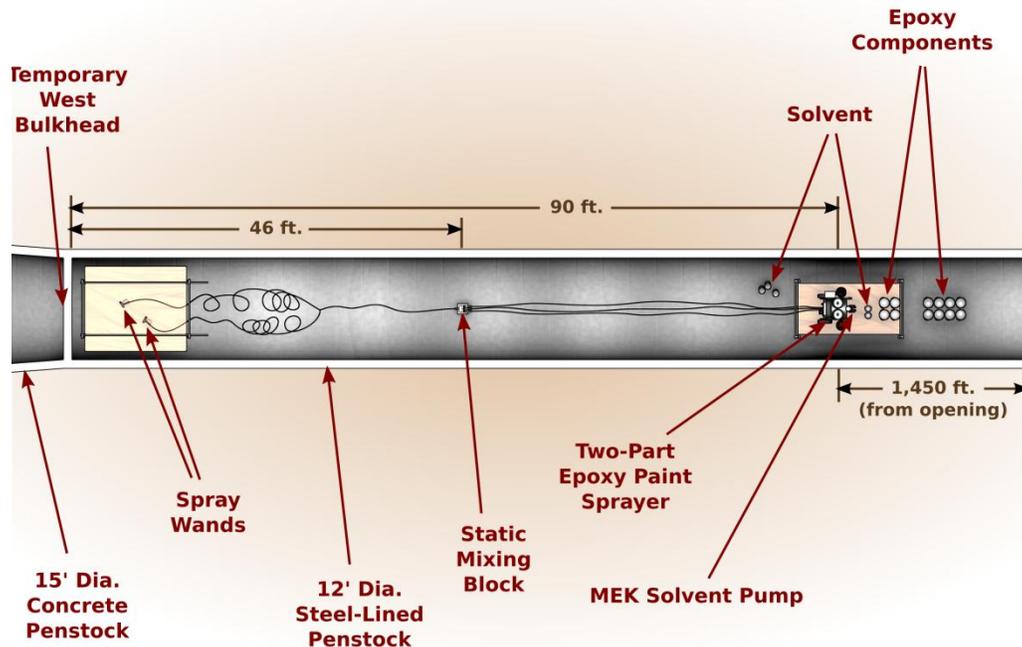
Figure 7. Aerial view of equipment arrangement in work area of the penstock

The sprayer was positioned in the penstock on wheeled scaffolding, which the RPI crew called the “stage,” about 1,450 feet (442 meters) from the access door and approximately 90 feet from the west bulkhead (Figure 7). The controls for the sprayer faced the west bulkhead, so that when a contractor was in position to manipulate the controls, he was looking in the direction of the access door, with the sprayer between him and that single point of egress.

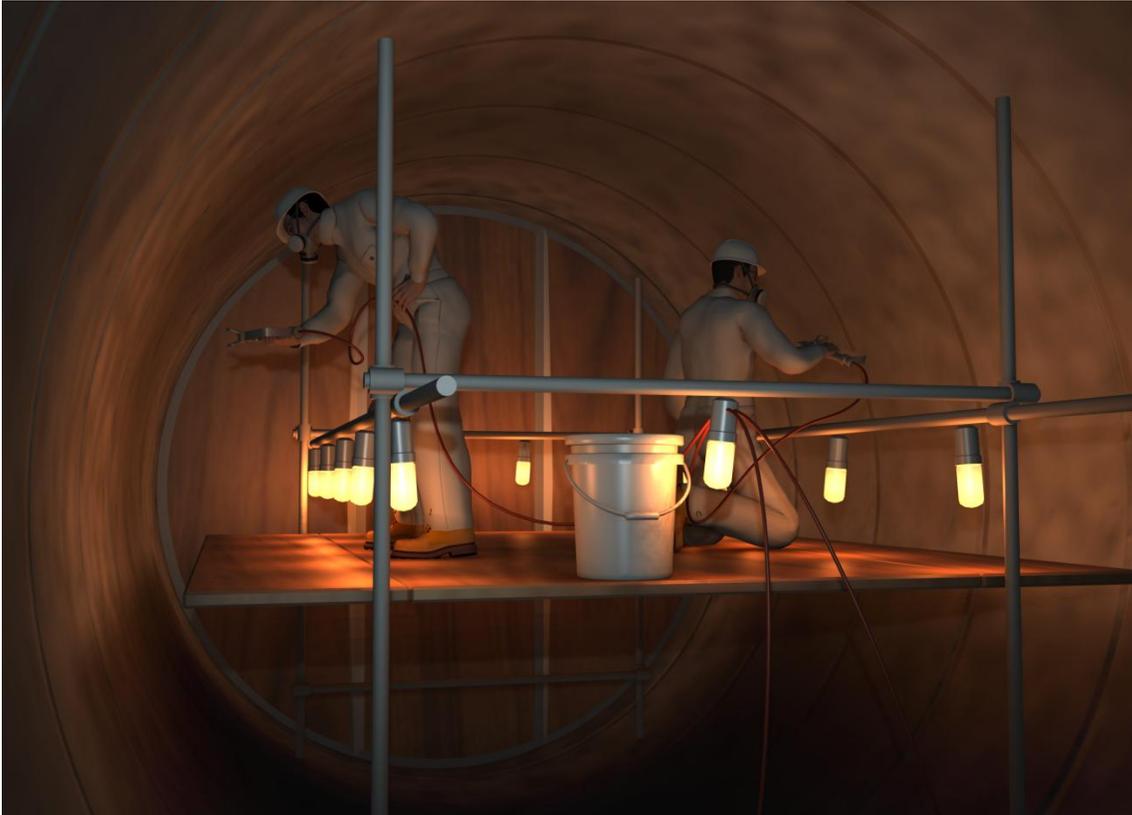
Figure 9. Depiction of contractors recoating the penstock interior near the temporary west bulkhead

The last two of the 13 contractors – besides the general foreman – were at the far end of the work area near the temporary west bulkhead, preparing to begin recoating the penstock interior using a wheeled scaffold that had been built for the crew as they used spray wands to recoat the penstock interior (Figure 9).

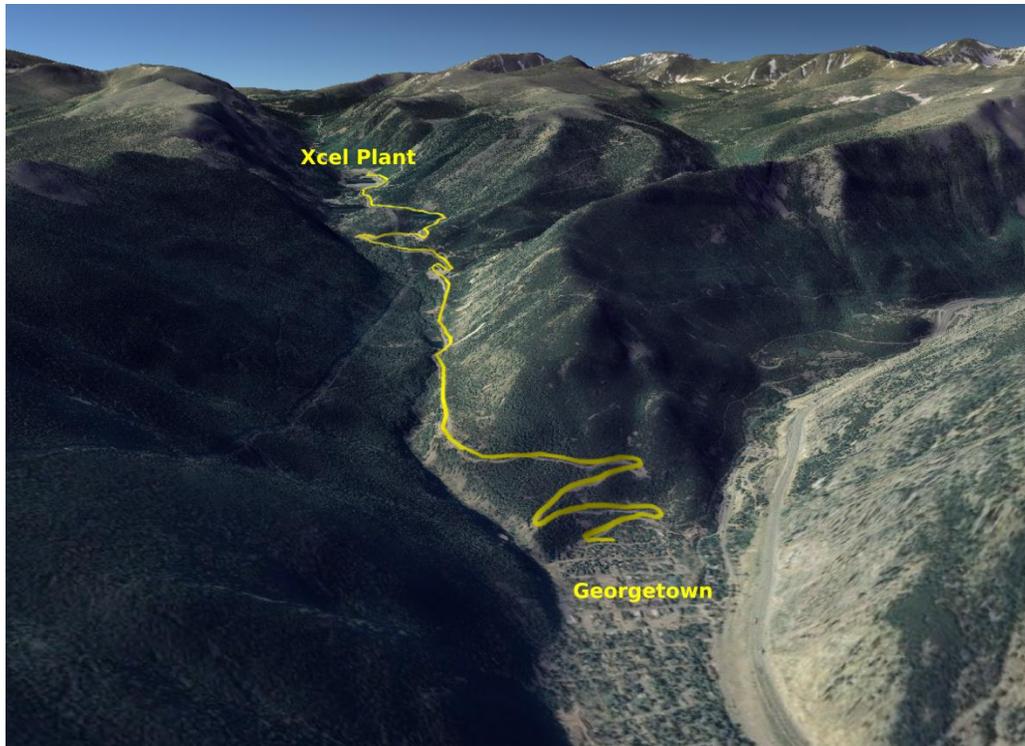
Figure 11. The winding, steep and narrow road from Georgetown to the Xcel hydroelectric plant

Depending on the road conditions, vehicle type, and speed, driving the 5.5 miles (8.9 kilometers) from the Georgetown fire station – the closest community emergency response facility – to the Cabin Creek hydroelectric plant takes between 10 and 30 minutes. At the time of the incident, the only improved road to the site, Guanella Pass, was steep, narrow, and winding (Figure 11). This road had no guardrails, was partially unpaved with loose gravel and potholes, and has many hairpin turns that made it hazardous to drive at speeds above 20 miles an hour (32 kilometers per hour).⁶⁵

⁶⁵ CCFA personnel told the CSB investigators that the turns were so tight that one of their fire support vehicles had to completely stop and back up several times to navigate through the turns.
