CASE STUDY

Fire at Formosa Plastics Corporation: Evaluating Process Hazards

2006-01-I-TX

Point Comfort, Texas
October 6, 2005

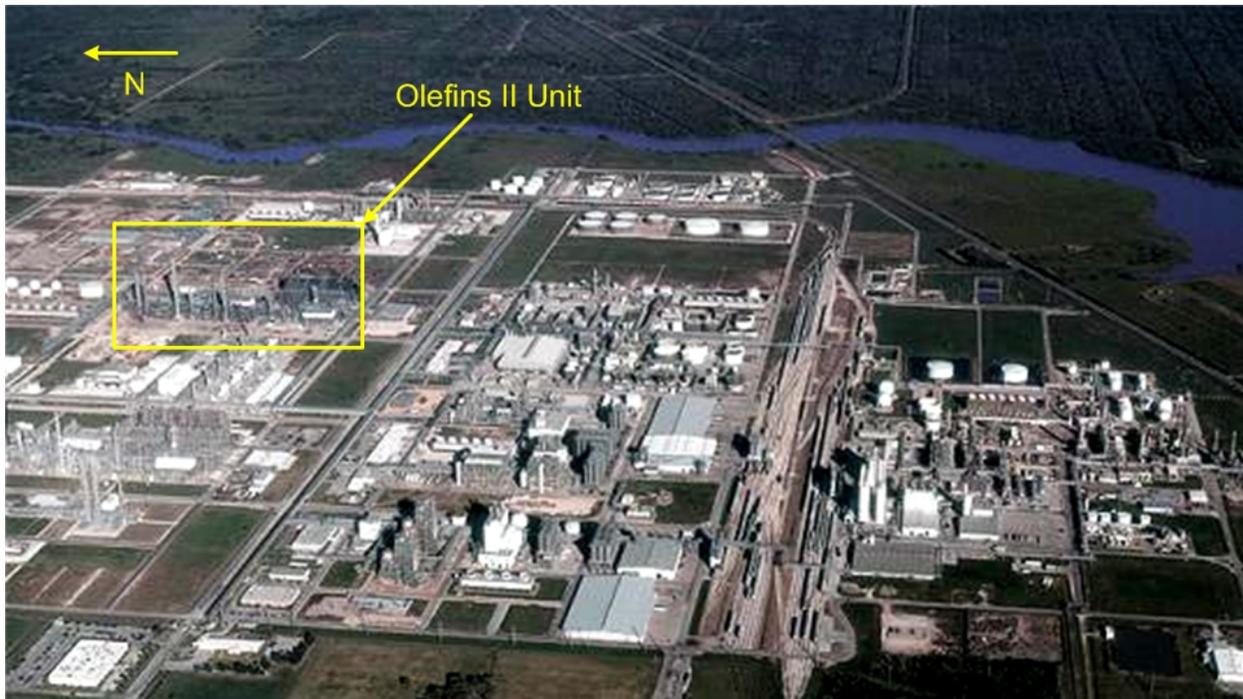
Figure 3. Formosa Point Comfort complex.

operations in 1983. The complex employs 1400 full-time workers and 400 contractors and covers 1,800 acres. The fire and explosions occurred in the Olefins II unit, one of 17 units at the complex (Figure 3).
